## Naval Arctic Research Laboratory (NARL) Subsurface Containment Berm Investigation

# **Naval Arctic Research Laboratory (NARL) Subsurface Containment Berm Investigation**

Final Report

Prepared for Naval Facilities Engineering Command (NAVFAC) Northwest  
1101 Tautog Circle  
Silverdale, WA 98315

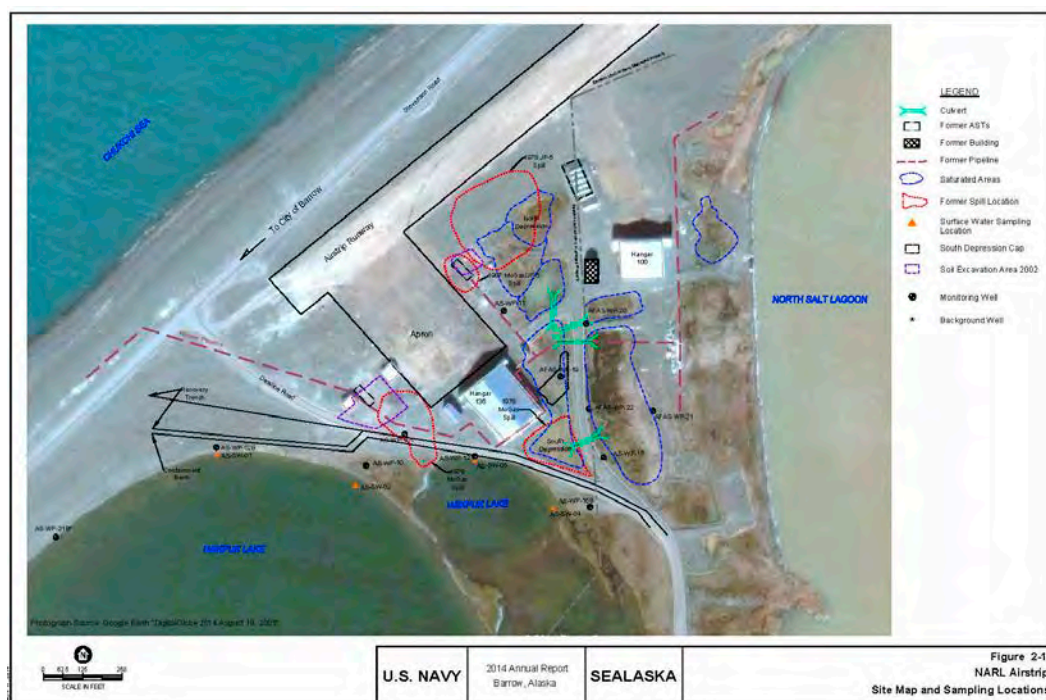
Figure 1. A plan view of the airstrip area, detailing the locations of the containment berm and recovery trenches (Naval Facilities Engineering Command Northwest [NAVFAC] 2014).

Over its history, NARL has cleaned up on-site fuel spills to various degrees and with various methods. One effort in particular, the installation of a subsurface containment berm and associated recovery trenches, was designed to exploit the cold conditions of Barrow and to create a raised permafrost feature that effectively prevents free product on the airfield from migrating into Imikpuk Lake (Figure 1).

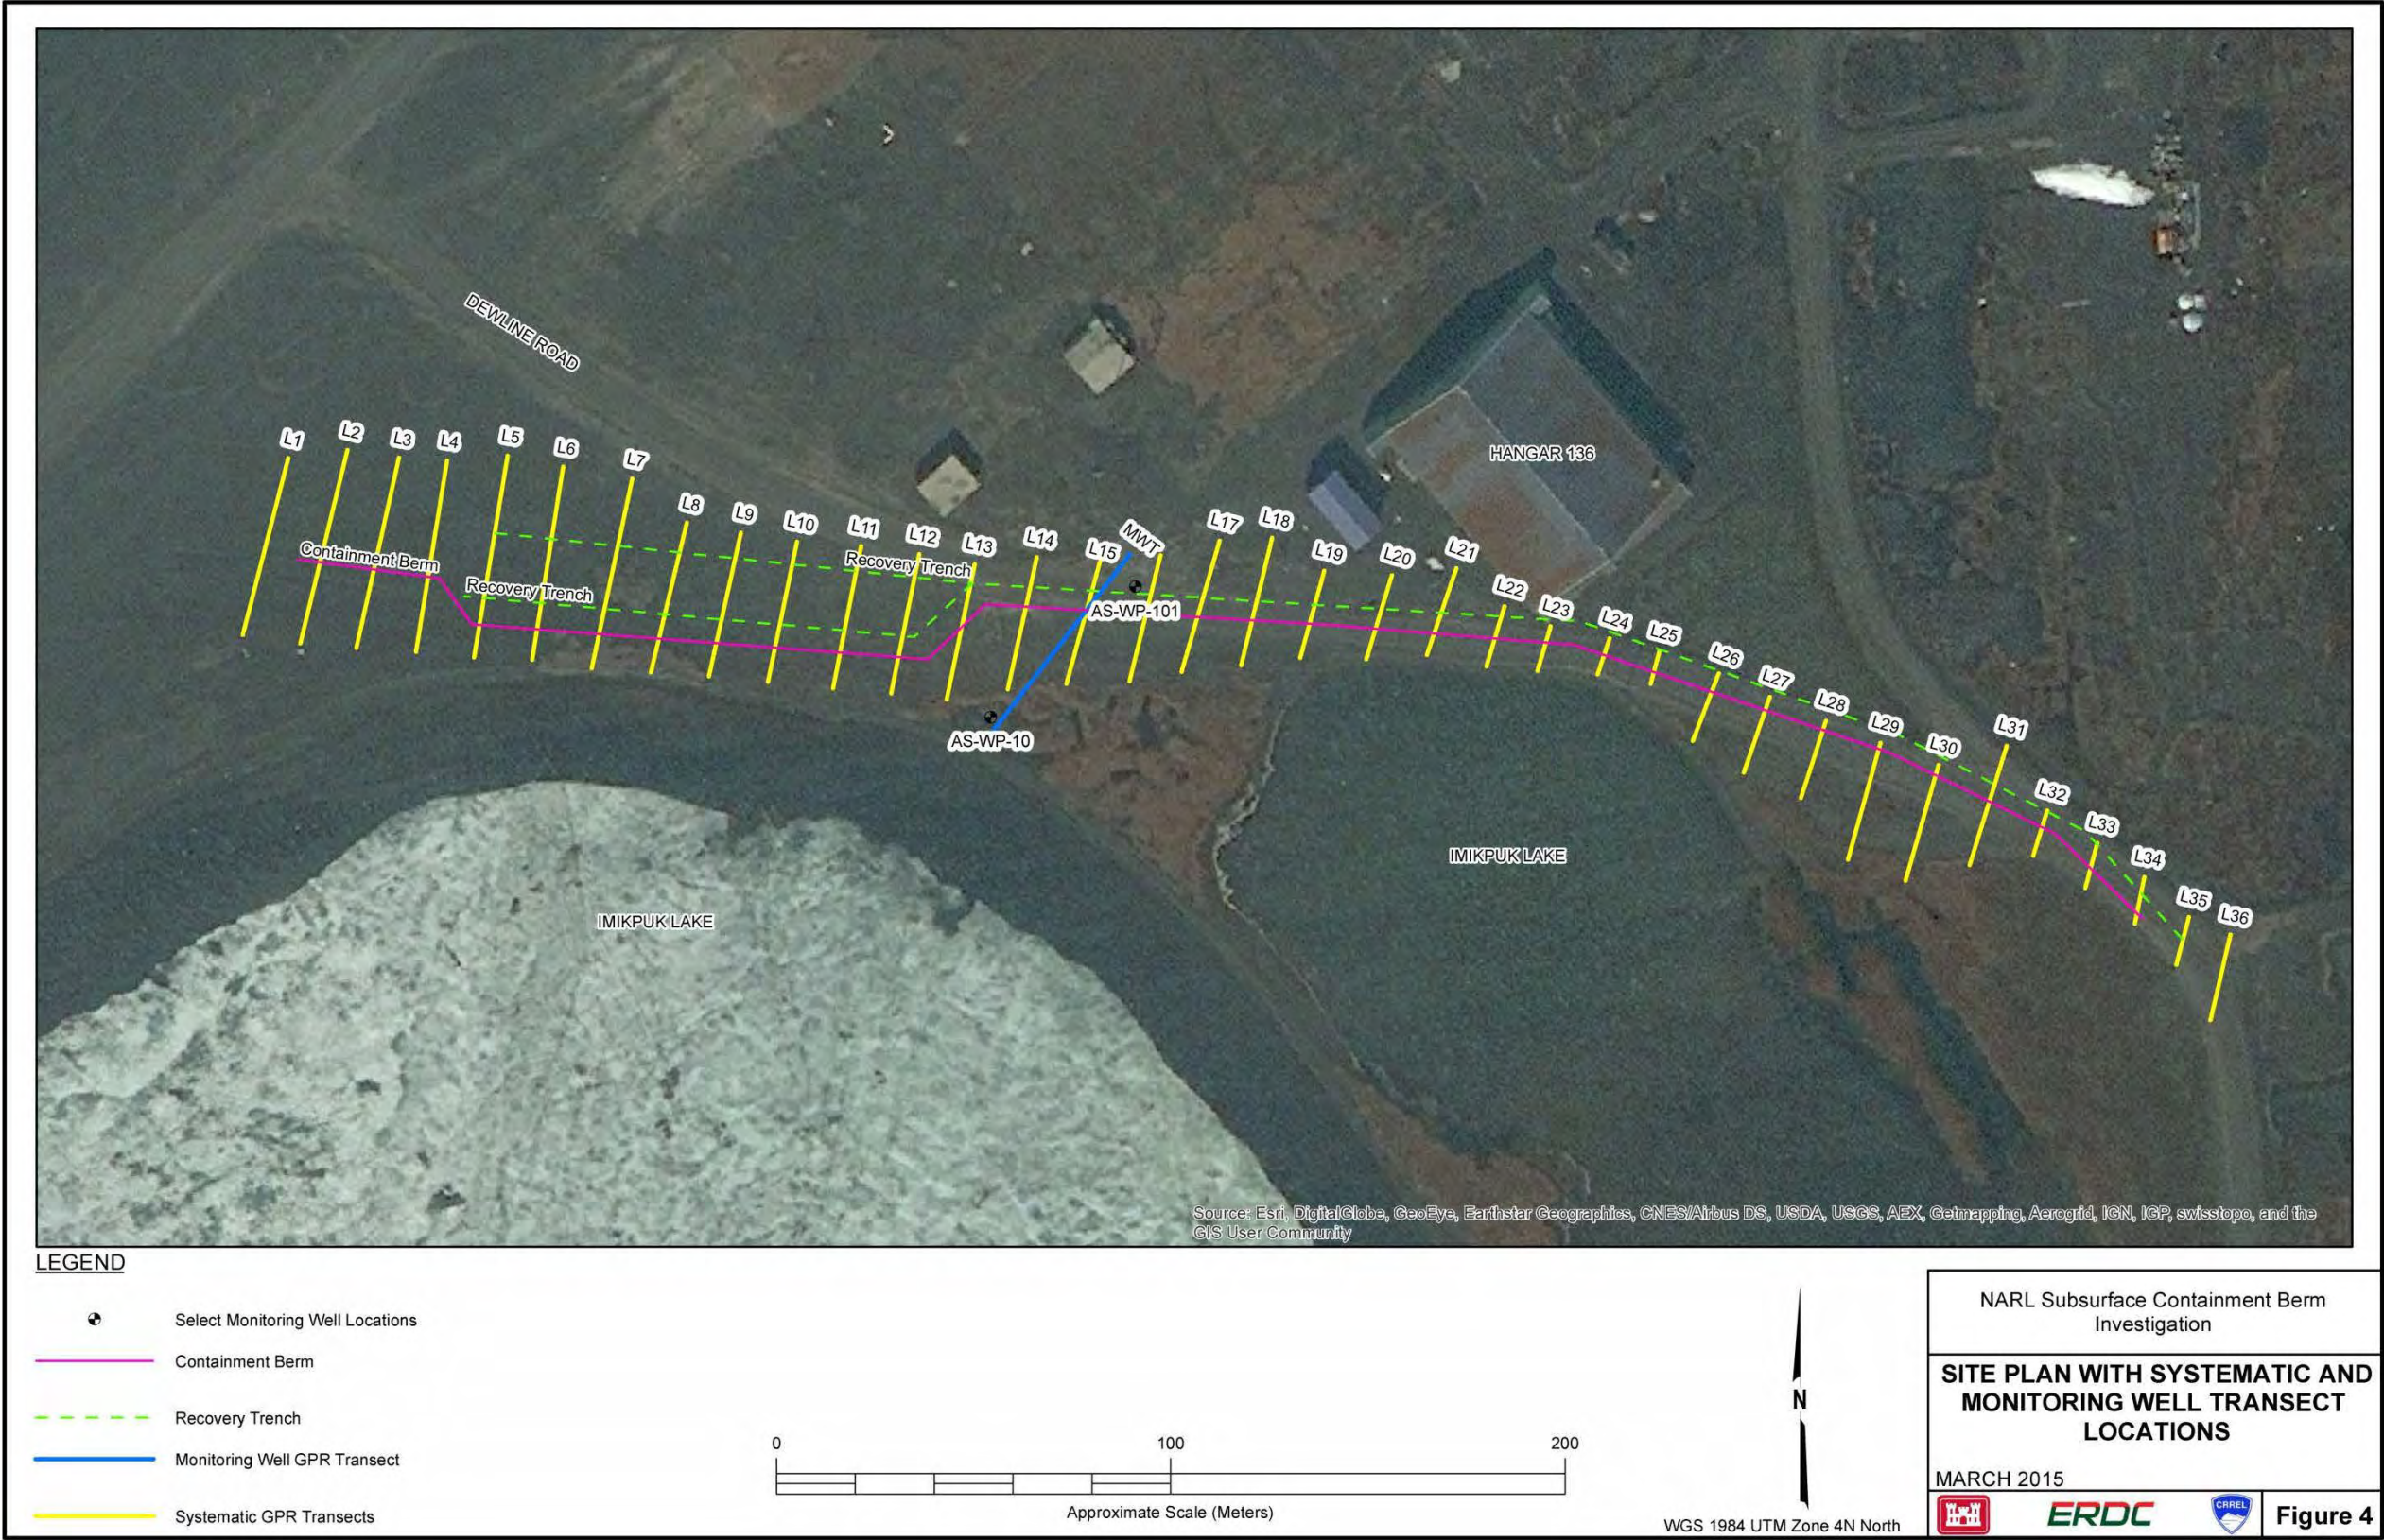
Figure 4. A site plan with systematic and Monitoring Well Transect (MWT) locations. The systematic transect locations are in yellow; the MWT is in blue.

We performed two longitudinal surveys in opposite directions directly over the axis of the berm for the full length and extending approximately 15 m beyond the ends of the berm. We compared the responses as a quality check of data and methods, and the responses correlated well. We completed one additional transect (Monitoring Well Transect—MWT) running in a straight line from 10 m north of monitoring well AS-WP-101 adjacent to the blue treatment building and then across the road to a point 10 m past monitoring well AS-WP-10 in the tundra and to the sands of Imikpuk Lake. The ice depth was measured in AS-WP-101 at 1.4 m, and frost depth was measured adjacent to AS-WP-10 at 0.8 m. Figure 4 shows a site plan with systematic transects and the MWT.
